ANALYSIS OF AN RCC FRAMED BUILDING STRUCTURE BY RAPID VISUAL SCREENING

Abstract- India's seismic record includes several devastating earthquakes that have caused immense loss of life and property. Notable among them are the Bhuj Earthquake (2001), the Indo-Nepal Earthquake (2015), the Kashmir Earthquake (2005), and the Great Assam Earthquake (1897), with many others adding to the toll. The scale of destruction seen in these events makes risk assessment and mitigation essential. Seismic design practices have advanced considerably over time, but so have the challenges, especially those tied to design and execution on ground. Regardless of the maintenance efforts, structural deterioration over the long term remains unavoidable. At the same time, rapid population growth and increasing pressure on land for urban expansion have led to widespread lapses in construction quality control across the country.

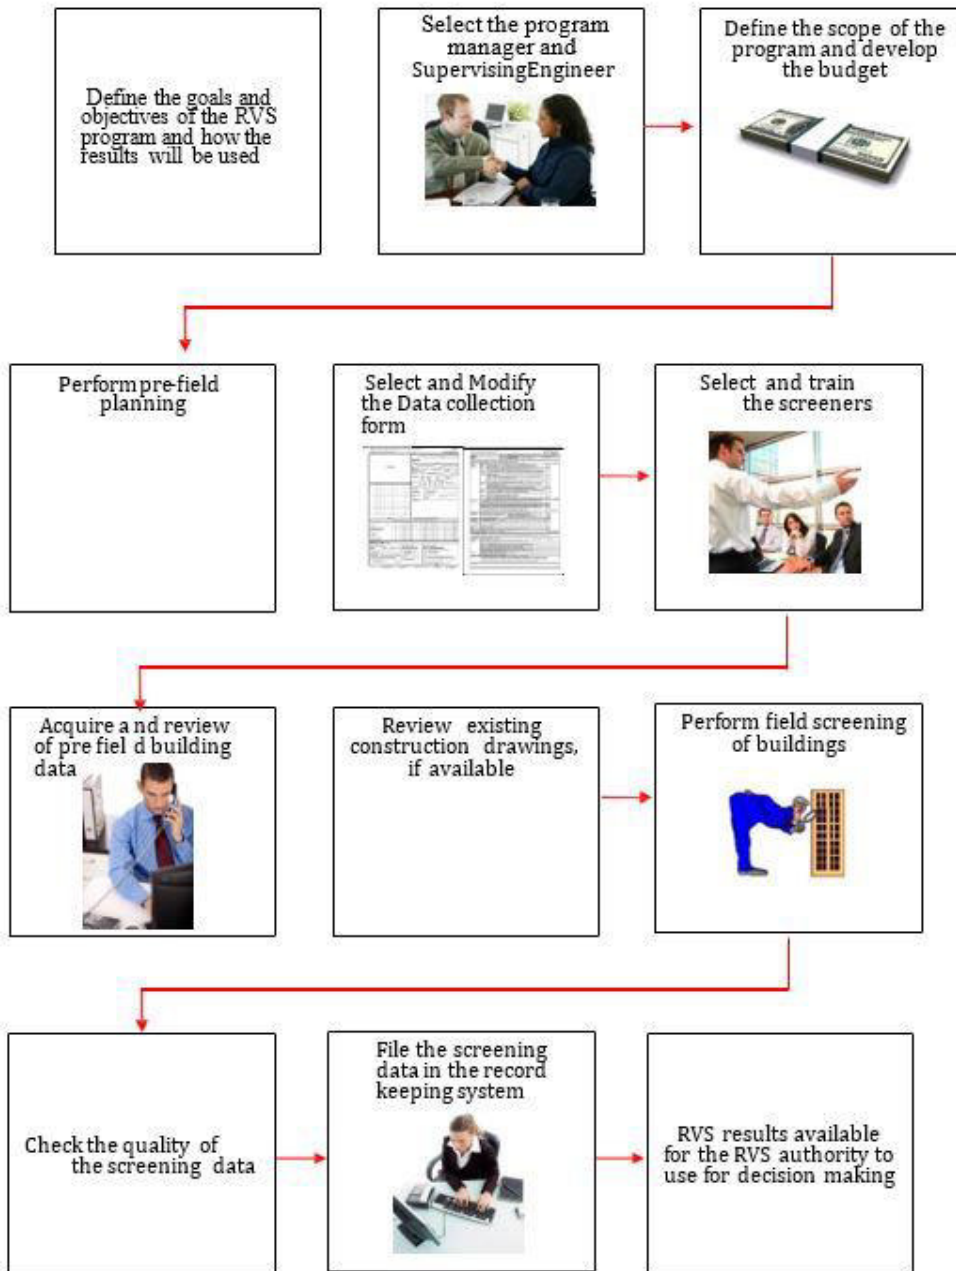
Figure 2: Basic Workflow Chart of RVS Procedure

The basic process as per this flowchart involves the following steps:

1. Defining the goals and objectives of the RVS program and how the results will be used.
2. Selecting the Program Manager and the Supervising Engineer.
3. Defining the scope of the program and develop the budget.

4. Performing pre-field planning, to identify the area to be surveyed, dividing it into a grid pattern and assigning teams to each area, collection of suitable local data about soil types etc.

5. Selection and modification of the Data Collection Form, to suit the needs of the current survey.
6. Selection and training of the screeners, making them aware of the methods of collecting and reporting data and the proper protocol to be followed.

7. Acquisition and review of pre-field building data.
8. Reviewing existing construction drawings, if available from the local municipal corporation or the builder that performed the construction.

9. Performing field screening of buildings.
10. Filing the screening data in the record-keeping system.
11. Quality check of the collected data and reviewing it to draw suitable conclusions about the survey quality.

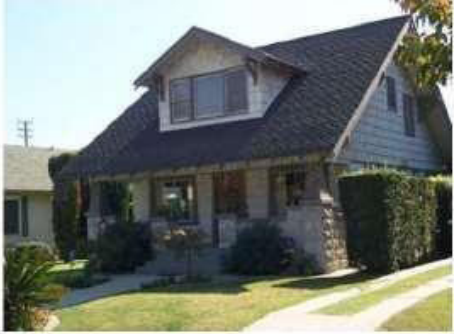
FEMA Building Type	Photograph	Basic Score	Characteristics and Performance
<p>W1 Light wood frame single- or multiple-family dwellings of one or more stories in height</p>

<p>(VH) = 2.1 (H) = 3.6 (MH) = 4.1 (M) = 5.1 (L) = 6.2</p>	<ul style="list-style-type: none"> • Wood stud walls are typically constructed of 2-inch by 4-inch (2-inch by 6-inch for multiple stories) vertical wood members set about 16 inches apart. • Most common exterior finish materials are wood siding, metal siding, or stucco. • Buildings of this type performed very well in past earthquakes due to inherent qualities of the structural system and because they are lightweight and low rise. • Earthquake-induced cracks in the plaster and stucco (if any) may appear, but are classified as non-structural damage. • The most common type of structural damage in older buildings results from a lack of connection between the superstructure and the foundation, and inadequate chimney support.

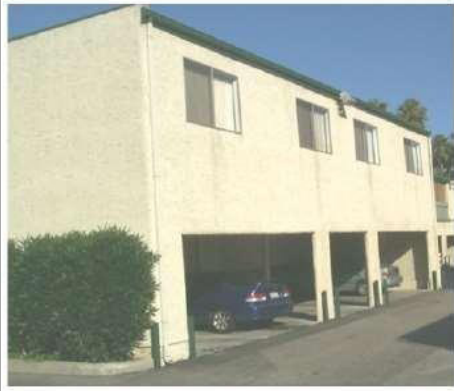
<p>W1A Light wood frame multi-unit, multi-story residential buildings with plan areas on each floor of greater than 3,000 square feet</p>

<p>(VH) = 1.9 (H) = 3.2 (MH) = 3.7 (M) = 4.5 (L) = 5.9</p>	<ul style="list-style-type: none"> • These are typically residential buildings, but some may have commercial space at the ground floor. • Large openings are common at the ground floor for parking. These are often termed tuckunder buildings. • W1A buildings with large openings at the ground floor for parking or commercial purposes have performed poorly in past earthquakes because the large openings create a soft story.

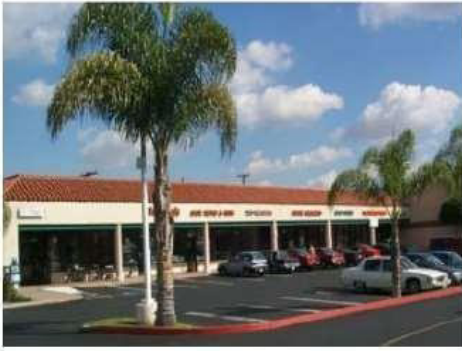
<p>W2 Wood frame commercial and industrial buildings with a floor area larger than 5,000 square feet</p>

<p>(VH) = 1.8 (H) = 2.9 (MH) = 3.2 (M) = 3.8 (L) = 5.7</p>	<ul style="list-style-type: none"> • These are typically commercial buildings or industrial structures usually of one to three stories, and, rarely, as tall as six stories. • For commercial and industrial buildings with less than 5,000 square feet, the W2 type can be assigned as well.
<p>S1 Steel moment-resisting frame</p>

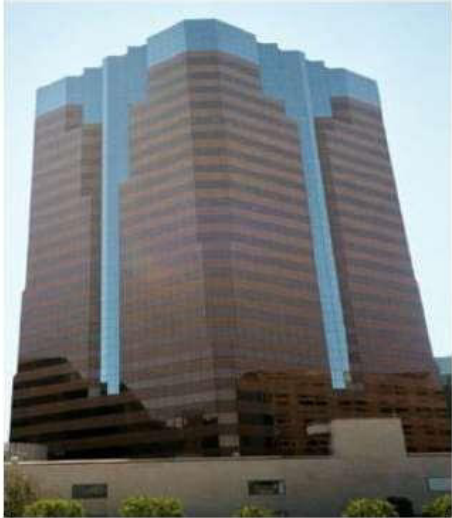
<p>(VH) = 1.5 (H) = 2.1 (MH) = 2.3 (M) = 2.7 (L) = 3.8</p>	<ul style="list-style-type: none"> • Typical steel moment-resisting frame structures have similar bay widths in both the transverse and longitudinal directions, around 20-30 feet. • The floor diaphragms are usually concrete, sometimes over steel decking. This structural type is used for commercial, institutional, and public buildings. • The 1994 Northridge and 1995 Kobe earthquakes showed that the welds in steel moment frame buildings were vulnerable to severe damage. The damage took the form of broken connections between the beams and columns. • The relatively low stiffness of the frame can lead to substantial nonstructural damage. • This building could also have a concrete seismic force-resisting system. See Appendix D for advice on how to identify FEMA Building Type.

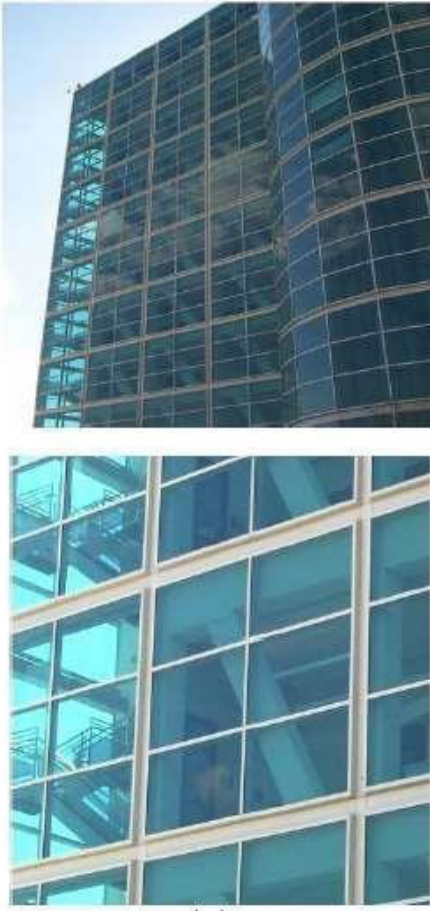
<p>S2 Braced steel frame</p>

<p>Close-up photo of building above</p>	<p>(VH) = 1.4 (H) = 0.2 (MH) = 2.2 (M) = 2.6 (L) = 3.9</p>	<ul style="list-style-type: none"> • These buildings are braced with diagonal members, which usually cannot be detected from the building exterior. • Braced frames are sometimes used for long and narrow buildings because of their stiffness. • From the building exterior, it is difficult to tell the difference between steel moment frames, steel braced frames, and steel frames with interior concrete shear walls. • In recent earthquakes, braced frames were found to have damage to brace connections and, in some cases to the braces, especially at the lower levels.
----------------------------------	--	--	--

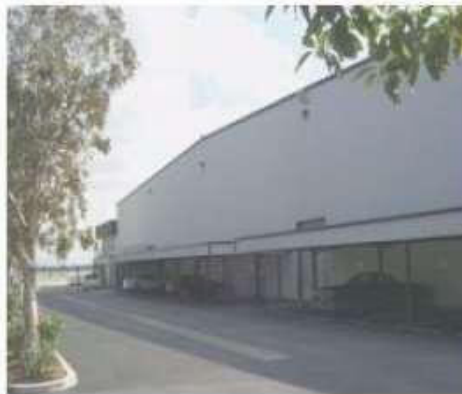
<p>S3 Light metal building</p>

<p>(VH) = 1.6 (H) = 2.6 (MH) = 2.9 (M) = 3.5 (L) = 4.4</p>	<ul style="list-style-type: none"> • The structural system usually consists of moment frames in the transverse direction and braced frames in the longitudinal direction, with corrugated sheet-metal siding. In some regions, light metal buildings may have partial height masonry walls. • The interiors of most of these buildings do not have interior finishes and their structural skeleton can be seen easily. • Insufficient capacity of tension braces can lead to their elongation and consequent building damage during earthquakes. • Inadequate connection to a slab foundation can allow the building columns to slide on the slab. • Loss of the cladding can occur.
------------------------------------	---	--	---

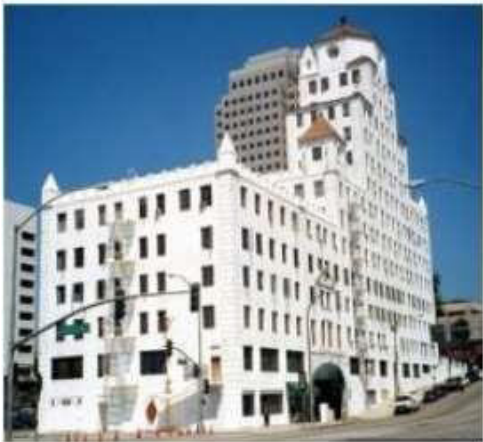
<p>S4 Steel frames with cast-in-place concrete shear walls</p>

<p>(VH) = 1.4 (H) = 2.0 (MH) = 2.2 (M) = 2.5 (L) = 4.1</p>	<ul style="list-style-type: none"> • Lateral loads are resisted by shear walls, which usually surround elevator cores and stairwells, and are covered by finish materials. • An interior investigation will permit a wall thickness check. A thickness in excess of six inches usually indicates a concrete shear wall. • Shear cracking and distress can occur around openings in concrete shear walls during earthquakes. • Wall construction joints can be weak planes, resulting in wall shear failure below expected capacity. • This building could also have a concrete frame. See Appendix D for advice on how to identify FEMA Building Type.
<p>S5 Steel frames with unreinforced masonry infill walls</p>

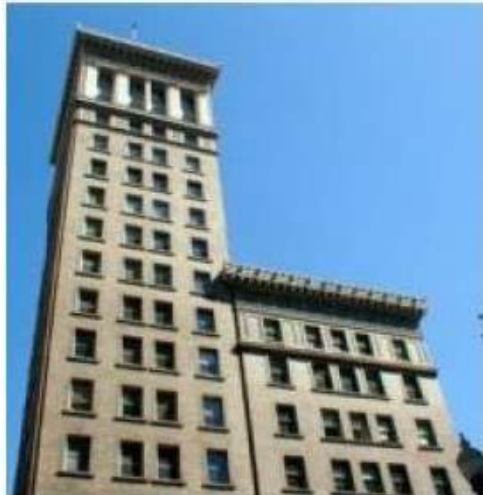
<p>(VH) = 1.2 (H) = 1.7 (MH) = 2.0 (M) = 2.7 (L) = 4.5</p>	<ul style="list-style-type: none"> • Steel columns are relatively thin and may be hidden in walls. • Usually masonry is exposed on exterior with narrow piers (less than 4 ft wide) between windows. • Portions of solid walls will align vertically. • Infill walls are usually two to three wythes thick. • Veneer masonry around columns or beams is usually poorly anchored and detaches easily. • This building could also have a concrete frame. See Appendix D for advice on how to identify FEMA Building Type.

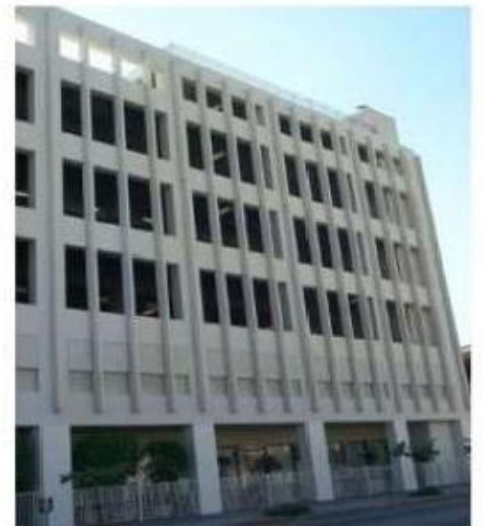
<p>C1 Concrete moment-resisting frames</p>

<p>(VH) = 1.0 (H) = 1.5 (MH) = 1.7 (M) = 2.1 (L) = 3.3</p>	<ul style="list-style-type: none"> • All exposed concrete frames are reinforced concrete (not steel frames encased in concrete). • A fundamental factor governing the performance of concrete moment-resisting frames is the level of ductile detailing. • Large spacing of ties in columns can lead to a lack of concrete confinement and shear failure. • Lack of continuous beam reinforcement can result in hinge formation during load reversal. • The relatively low stiffness of the frame can lead to substantial nonstructural damage. • Column damage due to pounding with adjacent buildings can occur.

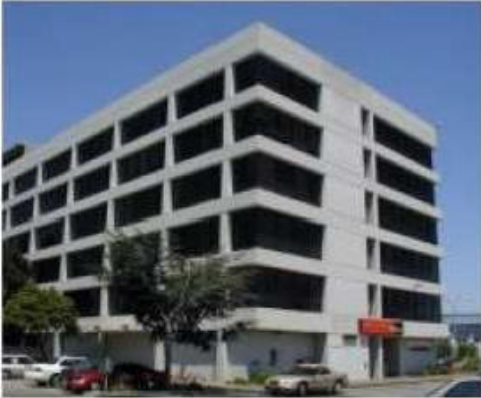
<p>C2 Concrete shear wall buildings</p>

<p>(VH) = 1.2 (H) = 2.0 (MH) = 2.1 (M) = 2.5 (L) = 4.2</p>	<ul style="list-style-type: none"> • Concrete shear wall buildings are usually cast-in-place, and show typical signs of cast-in-place concrete. • Shear wall thickness often ranges from 6 to 18 inches. • These buildings generally perform better than concrete frame buildings. • They are heavier than steel-frame buildings but more rigid due to the shear walls. • Damage commonly observed in taller buildings is caused by vertical discontinuities, pounding, and irregular configuration.
<p>C3 Concrete frames with unreinforced masonry infill walls</p>

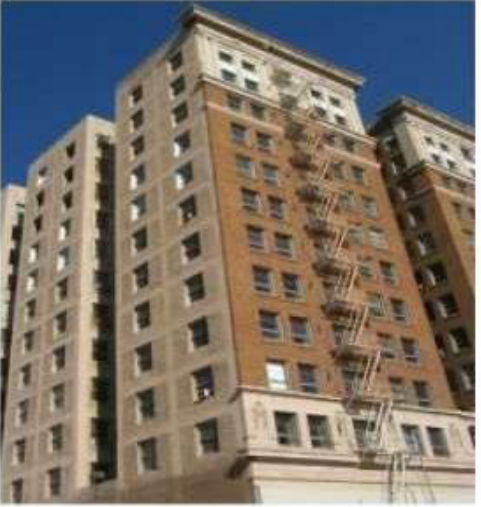
<p>(VH) = 0.9 (H) = 1.2 (MH) = 1.4 (M) = 2.0 (L) = 3.5</p>	<ul style="list-style-type: none"> • Concrete columns and beams may be full wall thickness and may be exposed for viewing on the sides and rear of the building. • Usually masonry is exposed on the exterior with narrow piers (less than four feet wide) between windows. • Portions of solid walls will align vertically. • This type of construction was generally built before 1940 in high seismicity regions but continues to be built in other regions. • Infill walls tend to buckle and fall out-of-plane when subjected to strong lateral out-of-plane forces. • Veneer masonry around columns or beams is usually poorly anchored and detaches easily.

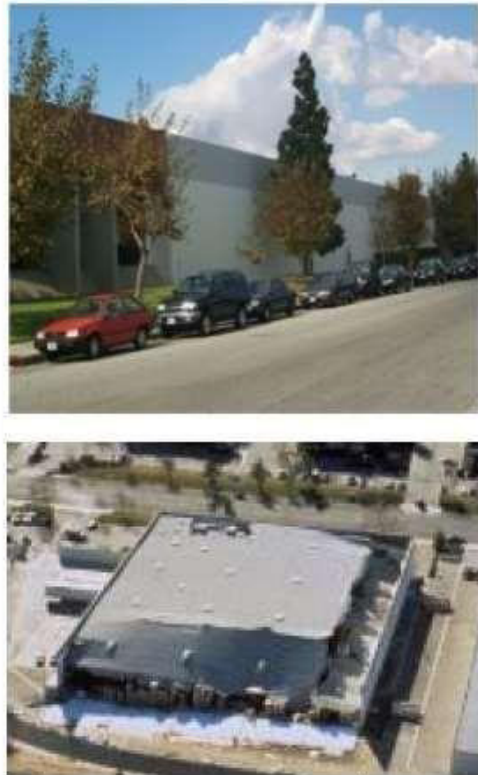
<p>PC1 Tilt-up buildings</p>

<p>Partial roof collapse due to failed diaphragm-to-wall connection</p>	<p>(VH) = 1.1 (H) = 1.6 (MH) = 1.8 (M) = 2.1 (L) = 3.8</p>	<ul style="list-style-type: none"> • Tilt-ups are typically one or two stories high and are basically rectangular in plan. • Exterior walls were traditionally formed and cast on the ground adjacent to their final position, and then tilted up and attached to the floor slab. • The roof can be a plywood diaphragm carried on wood purlins and glulam beams or a light steel deck and joist system, supported in the interior of the building on steel pipe columns. • Weak diaphragm-to-wall anchorage results in the wall panels falling and the collapse of the supported diaphragm (or roof).
----------------------------------	---	--	--

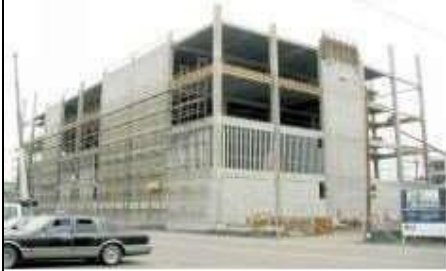
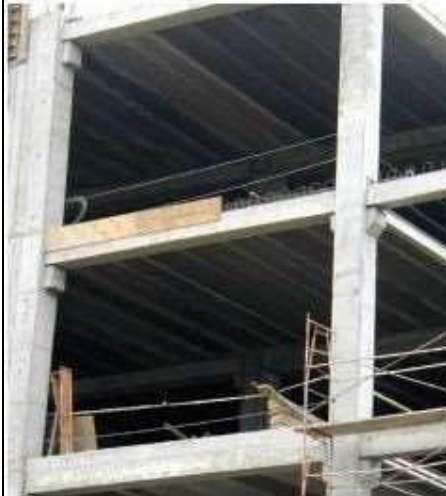
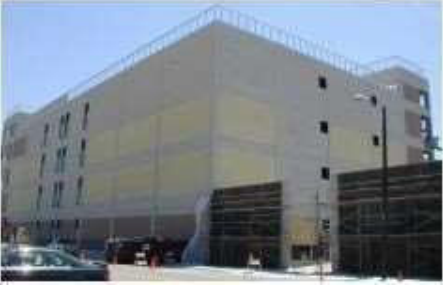
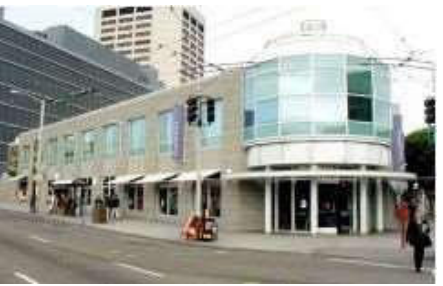
<p>PC2 Precast</p>

<p>Building under construction</p>

<p>(VH)=1.0 (H)=1.4 (MH)=1.5</p>	<p>Precast concrete frames are in essence, post and beam construction in concrete.</p> <p>Structures often employ concrete or reinforced masonry (brick or block) shear walls.</p> <p>The performance varies widely and is sometimes poor. In addition to damage to shear walls similar to C2 buildings, PC2 buildings have additional issues as follows.</p> <p>Poorly designed connections between prefabricated elements can fail.</p>
------------------------	--	--	---

<p>concrete frame buildings</p>	<p>(M)=1.9 (L)=3.3</p> <p>Detail of the precast components</p>

<p>Building nearing completion</p>	<p>Loss of vertical support can occur due to inadequate bearing area and insufficient connection between floor elements and columns.</p> <p>Corrosion of metal connectors between prefabricated elements can occur.</p>
---	---	---

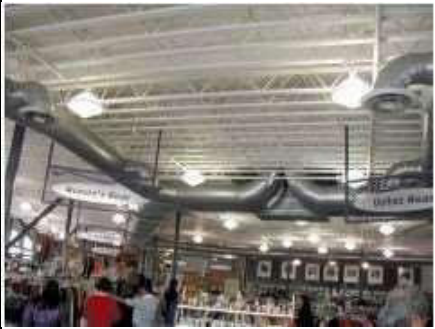
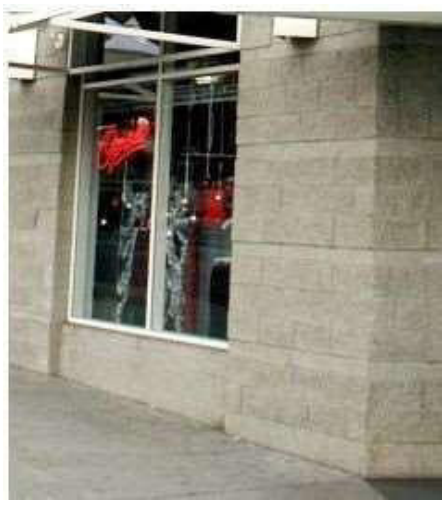
<p>RM1</p> <p>Reinforced masonry buildings with flexible</p>

<p>Truss-joints support plywood and light- weight concrete slab</p>	<p>(VH)=1.1</p> <p>(H)=1.7</p> <p>(MH)=1.8</p> <p>(M)=2.1</p> <p>(L)=3.7</p>	<p>rigid.</p> <p>The most common flexible floor and roof diaphragm systems are wood or light steel.</p> <p>These buildings can perform well in moderate earthquakes if they are adequately reinforced and grouted, with sufficient diaphragm anchorage.</p> <p>Poor construction practice can result in ungrouted and</p>
--	---	--	---

<p>Detail showing reinforced masonry</p>	<p>unreinforced walls, which will fail easily.</p>
-------------------	--	--

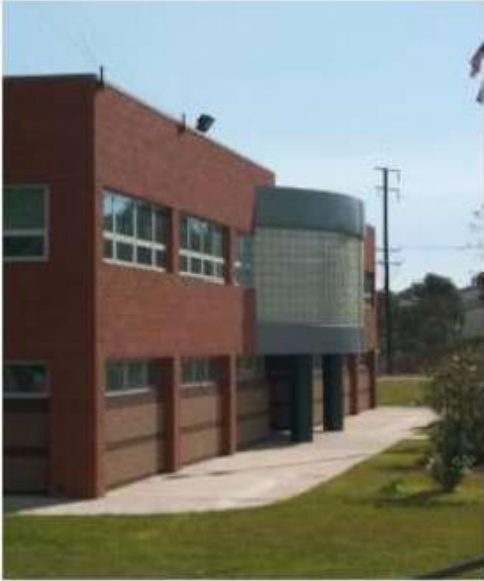
<p>RM2 Reinforced masonry buildings with rigid diaphragms</p>

<p>(VH) = 1.1 (H) = 1.7 (MH) = 1.8 (M) = 2.1 (L) = 3.7</p>	<ul style="list-style-type: none"> • Walls are either brick or concrete block. • Wall thickness is usually 8 inches to 12 inches. • Interior inspection is required to determine if diaphragms are flexible or rigid. • The most common rigid floor and roof diaphragm systems are precast concrete or concrete over metal deck. • These buildings can perform well in moderate earthquakes if they are adequately reinforced and grouted, with sufficient diaphragm anchorage. • Poor construction practice can result in ungrouted and unreinforced walls, which will fail easily.
<p>URM Unreinforced masonry buildings</p>

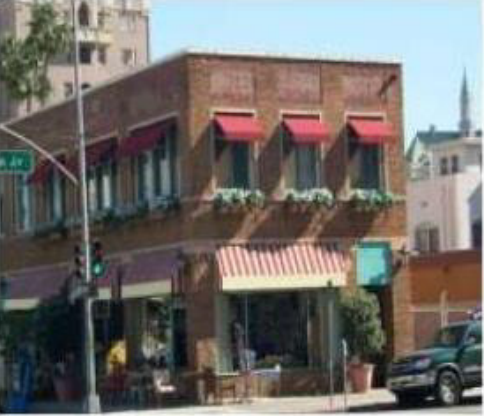
<p>(VH) = 0.9 (H) = 1.0 (MH) = 1.2 (M) = 1.7 (L) = 3.2</p>	<ul style="list-style-type: none"> • These buildings often used weak lime mortar to bond the masonry units together. • Arches are often an architectural characteristic of older brick bearing wall buildings. • Other methods of spanning are also used, including steel and stone lintels. • Unreinforced masonry usually shows header bricks in the wall surface. • The performance of this type of construction is poor due to lack of anchorage of walls to floors and roof, soft mortar, and narrow piers between window openings.

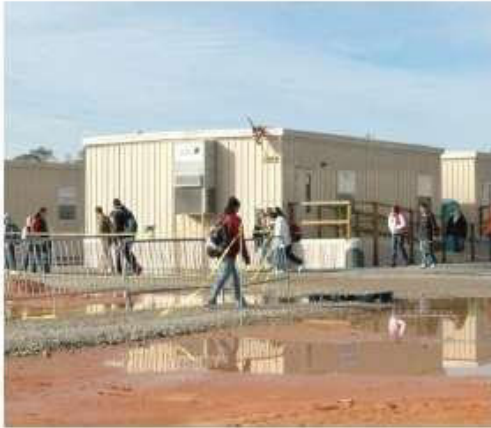
<p>MH Manufactured housing</p>

<p>(VH) = 1.4 (H) = 1.8 (MH) = 2.2 (M) = 2.9 (L) = 4.6</p>	<ul style="list-style-type: none"> • These buildings can be mobile homes or modular buildings, such as those used for portable classrooms. • The buildings are mobile, raised up off the ground, not anchored to the ground, and may or may not have an earthquake resistant bracing system (ERBS). • Manufactured homes are typically one story and come in different sizes. A single-wide unit can be up to 18 feet in width. A double-wide unit is 20 feet or more in width. • Floors and roofs are usually constructed with plywood or oriented strand board, and the outside surfaces are covered with sheet metal. • The primary source of damage is due to the lack of a permanent foundation connection or an earthquake-resistant bracing system (ERBS). In moderate shaking, the building can fall off its supports, and jack stands can penetrate the floor. Connecting utility lines can be severed, and escaping gas can cause fires.
